Road Talk

Discovering the Invisible: Using Ground-Penetrating Radar

The Ministry of Transportation tests 3D imaging to evaluate pavement conditions

Ontario's Ministry of Transportation (MTO) recently tested three-dimensional (3D) ground-penetrating radar (GPR) on Highway 417 to identify deteriorating pavement joints.

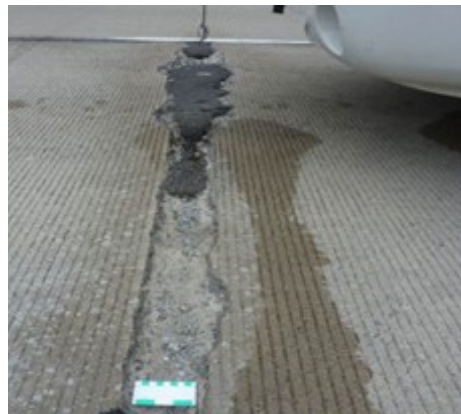
Figure 6a: Concrete with underlying joint distress visible from the surface.

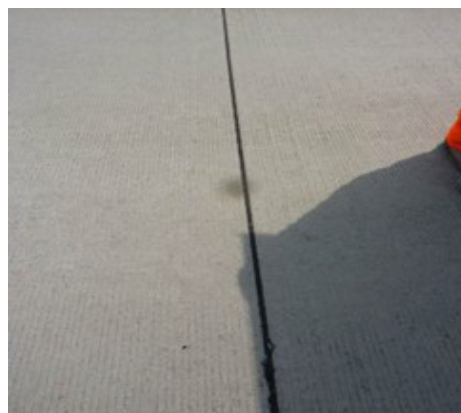
Figure 6b: Concrete with underlying joint distress not visible from the surface.

The data revealed areas where surface distress had not yet occurred despite distress in the subsurface – crucial information for the ministry to identify potential future areas of surface distress and make informed maintenance and rehabilitation decisions.

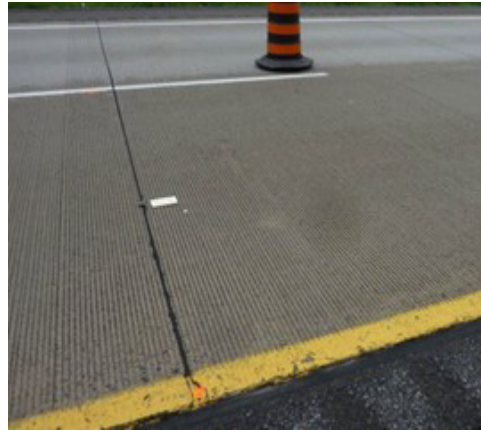
In 2013, a 10-km section of Highway 417 started to show signs of joint distress eight years after construction. Pavement cores taken from the highway revealed damage below the joint sealant that were not visible on the surface. These findings prompted investigations on other MTO highways to assess the extent of the problem and provide solutions.

Figure 7a: Concrete joint deterioration without surface signs.

Based on the investigations, the ministry made significant updates to improve its concrete pavement specifications. Changes were made to ensure concrete is more durable in a saturated freeze-thaw environment. Joints were redesigned to minimize the degree of concrete saturation.

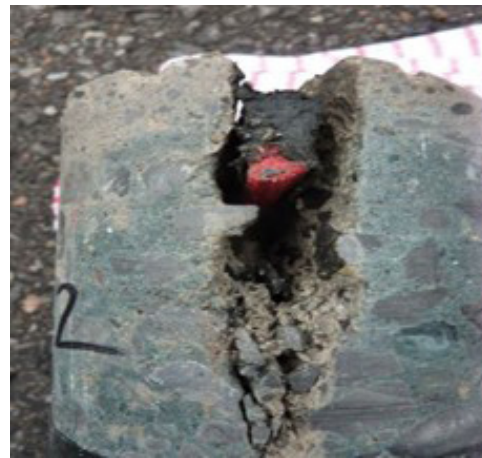
Figure 7b: Concrete joint deterioration shown in core sample.

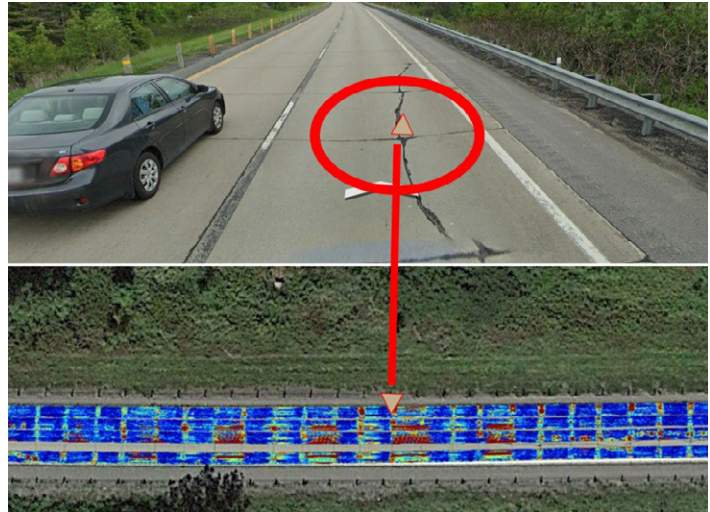
Figure 10: Area of distress confirmed by heat map location.

The GPR data analysis for Highway 417 recommended focusing on the 50 mm depth and the bottom of the concrete layer to accurately assess the pavement condition. MTO suggested intrusive testing at 20 locations to further investigate distresses detected in the GPR data.

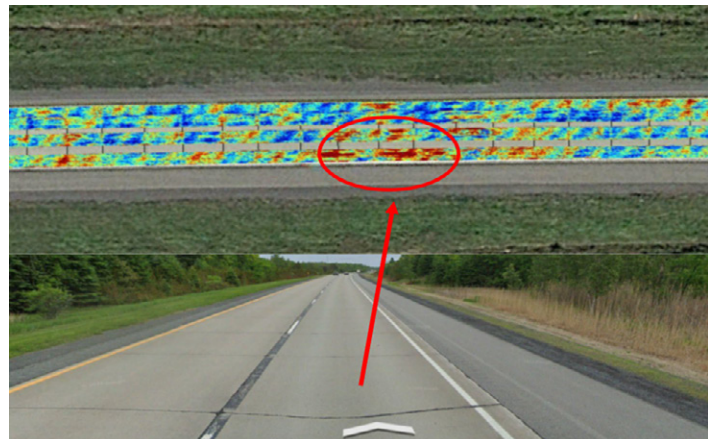
Figure 11: Distress area in 3D GPR heat map is not clear from surface observation.
