Corrosion of Roof Truss Connector Plates in Farm Buildings

S. Beadle, P.Eng.

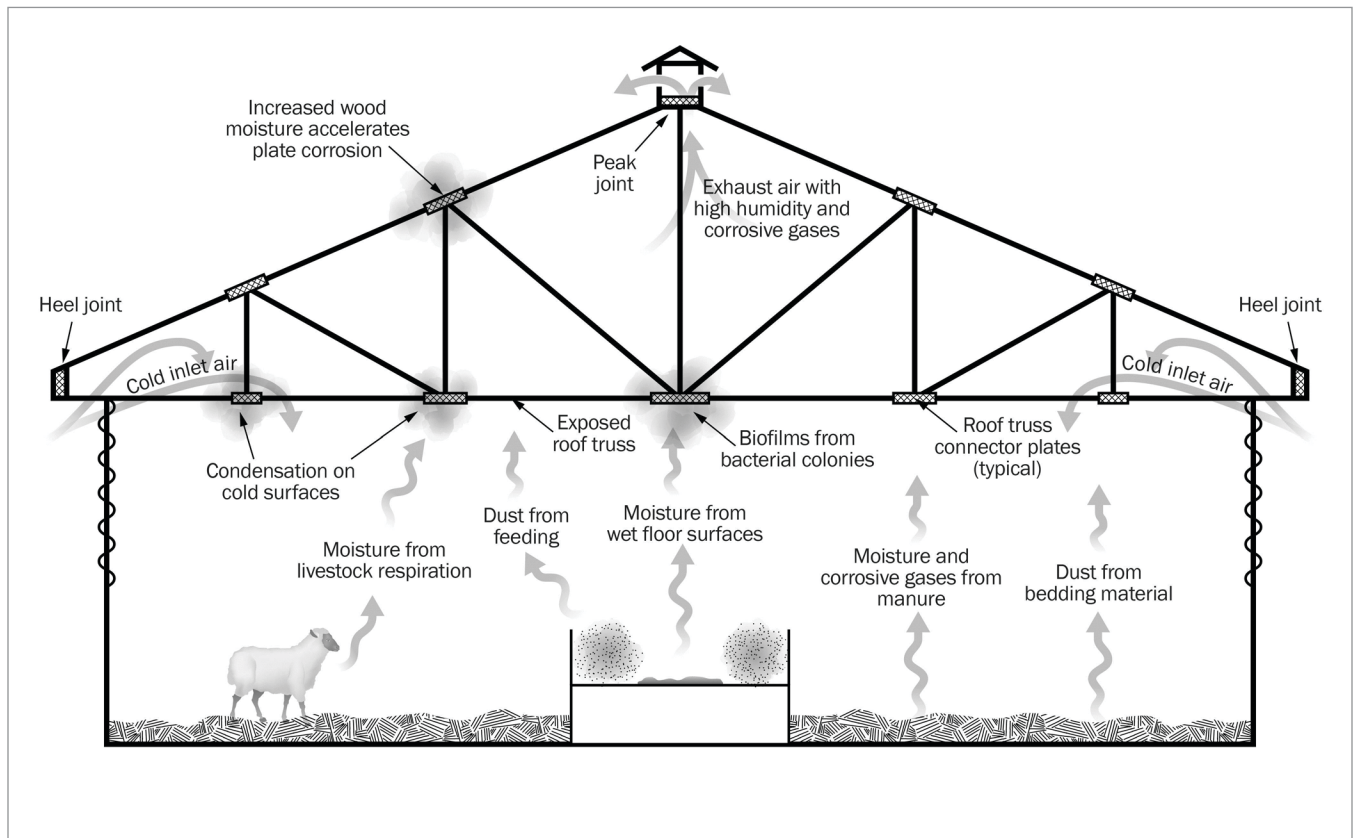
Livestock barns and roofed manure storages without ceilings are often affected by corrosion. These buildings allow moisture, corrosive gases and dust direct access to the trusses and connector plates (Figure 2). The connector plates often show the greatest deterioration near the building air exchange openings, at the heel and peak joints of the truss. These are the areas of significant air mixing and temperature changes, coupled with high humidity and corrosive gas concentrations, producing ideal conditions for corrosion. The heel and peak joints are critical to the structural integrity of the trusses.

Figure 2. Sources of moisture, corrosive agents and dust that cause corrosion. This barn has no ceiling, allowing contaminants direct access to the truss and connector plates.
