Road Talk

Exploring the Reuse of Pile Foundations: *Assessing the Longevity of Steel*

Ontario's Ministry of Transportation (MTO) is exploring the reuse of steel pile foundations in bridges to improve safety and traffic mobility, lower costs and benefit the environment.

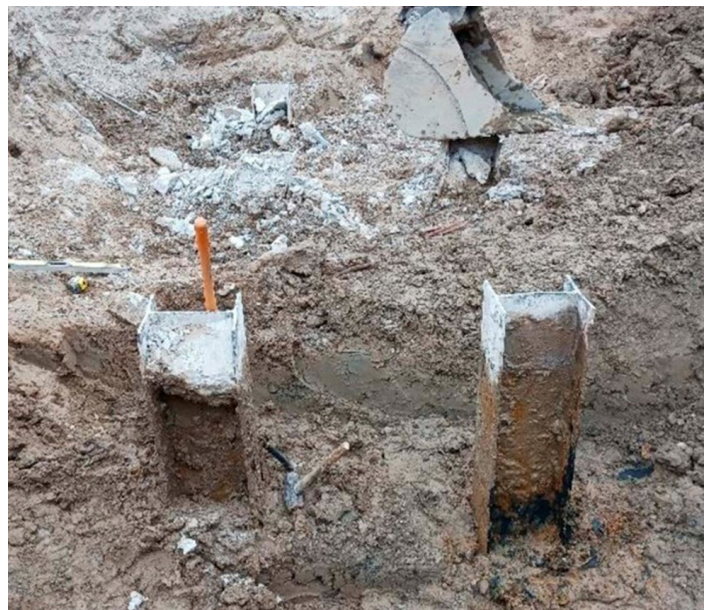
Figure 2: Exposed H-piles at the Leslie Street interchange.

In Toronto, the Highway 401/Leslie Street interchange improvement project involved demolishing an old bridge and building a new one. The steel H-piles supporting the old bridge were installed approximately 60 years ago. After removing the pile cap at one of the abutments, MTO found the H-piles exhibited limited corrosion.

The overall thickness loss across the piles was relatively modest, averaging around three per cent. These results confirmed that most of the steel remained in good condition.

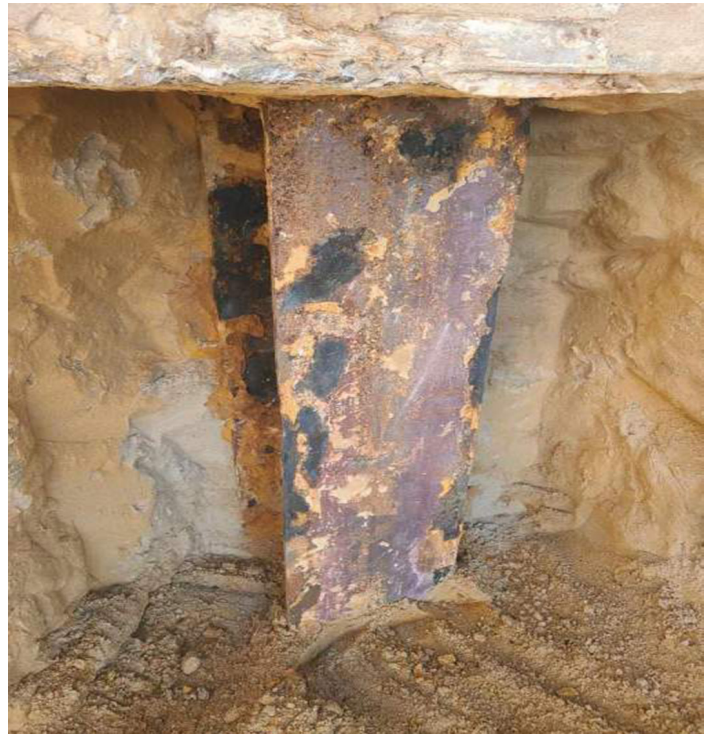
Figure 3: Pre-blast cleaning of pile W3 at Woodroffe Avenue.

In Ottawa, MTO replaced several bridges on Highway 417 that were built between 1960 and 1968 using the rapid bridge replacement technique. At the Woodroffe Avenue and Richmond Road sites, crews installed temporary shoring to excavate the soil surrounding the piles beneath the existing abutments.

Corrosion on the exposed piles was within safe and acceptable limits and MTO concluded they could be reused.

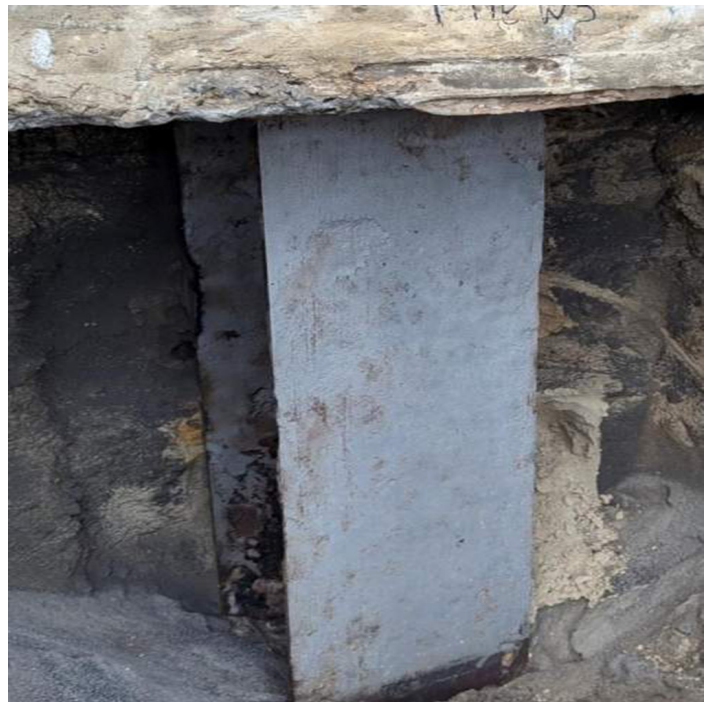
Figure 4: Post-blast cleaning of pile W3 at Woodroffe Avenue.

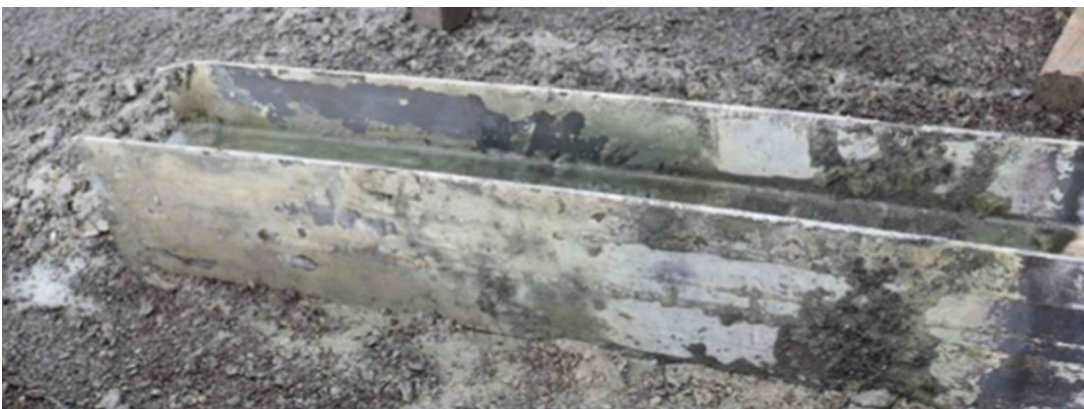
Figure 5: The piles at the Highway 401 and Hallecks Road interchange show minimal corrosion.

For this project, the existing four-span bridge at Highway 401 and Hallecks Road in Brockville was replaced with a two-span bridge. MTO extracted and assessed two existing piles from the piers and two from the abutment. Overall, the piles exhibited limited corrosion.

The ministry also used borehole magnetometry and parallel seismic testing to verify pile lengths and confirm they had been driven to bedrock.

Based on the results of the ultrasonic testing and chemical analysis, the Brockville piles would still offer structural resistance for potential reuse.
